Manhole Inspection Summary

Manhole # S37Q__002MH

Location Address: **424 sanders st**

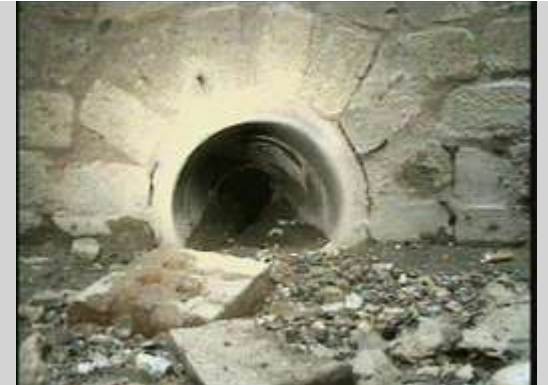
12 O'Clock Outflow

8 in. Circular Gravity Sewer
Pipe Out @ 12 O'Clock

Infiltration: **None** Pipe Seal Cond: **Unknown**
